LANDSCAPE STUDY

The Garden of University House (*“Casa Universitarilor”*)

(Liebrecht-Filipescu House)

Dionisie Lupu Street, no. 46, Bucharest

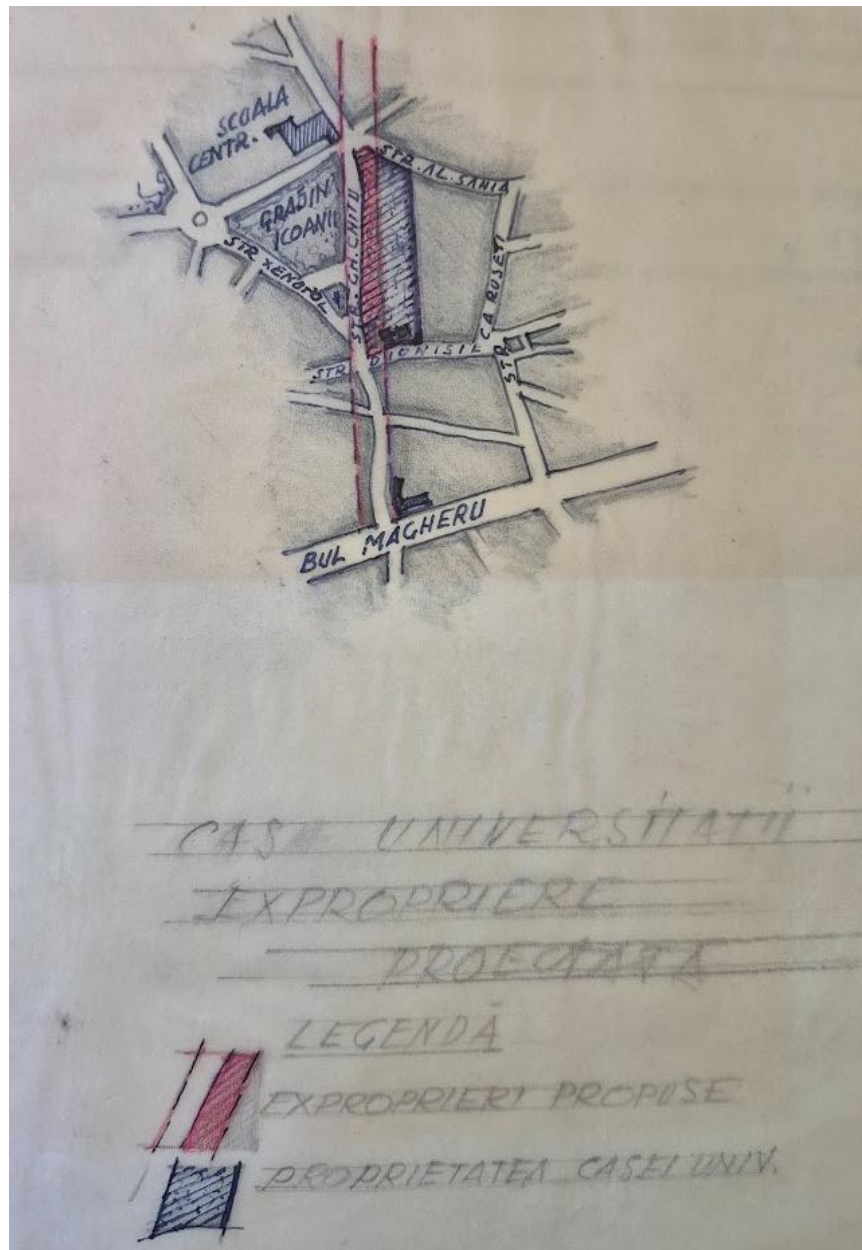
Proposal for expropriation and systematization in order to widen and align Gen. Chițu Street (today Arthur Verona), 1957. Source: INP archive, file 1976

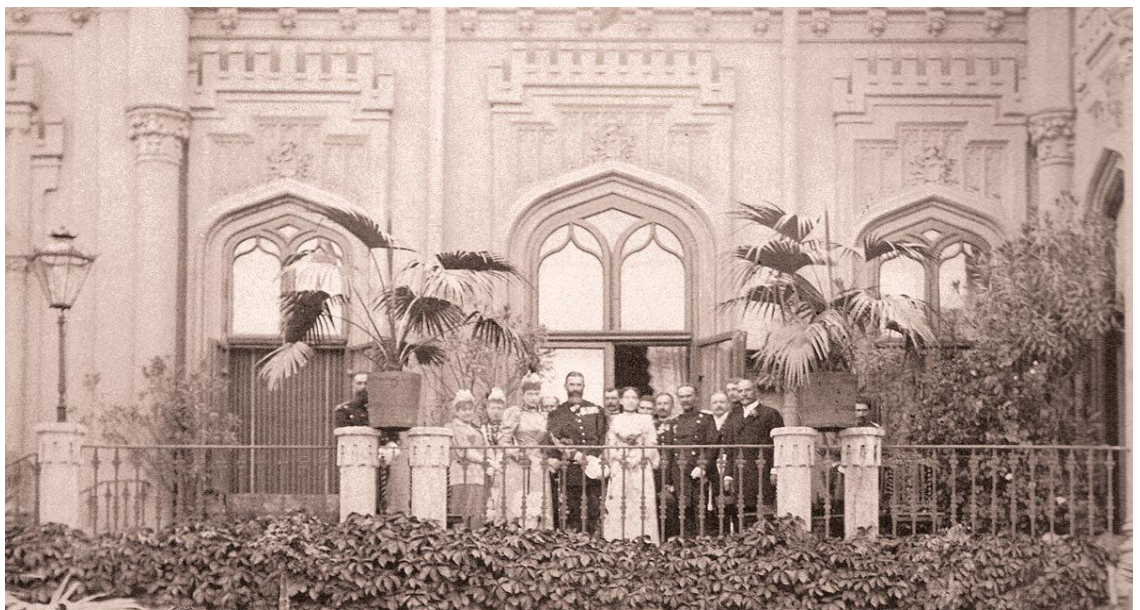
Vintage images showing a wall covered with Canada vine (*Parthenocissus quinquefolia*, in the foreground) and several flower pots, including palm pots.

Also, based on another vintage photograph from the same historical set, a wall covered with Canada Vine (*Parthenocissus quinquefolia*) and two pots with palm trees (possibly similar to those on the lawn) can be identified.

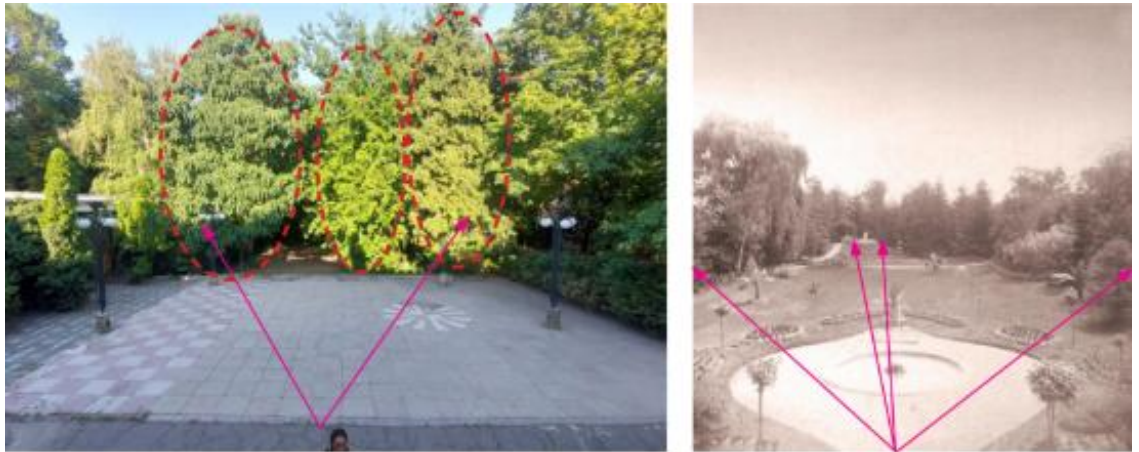
was unkempt, and some of the trees and shrubs completely obstructed certain important historical perspectives, which required punctual cutting and shaping interventions, as well as the removal of dry vegetation. At the same time, it results that some pedestrian alleys in the historical garden were paved with stone slabs, concrete slabs and cubic stone, the design team proposing to cover them with a layer of gravel - a proposal that was implemented.

Comparative analysis reported to the main historical perspective open to the garden, 2022

20. It is recommended to restore or even, as the case may be, recreate the historical perspective captured in the period photographs.

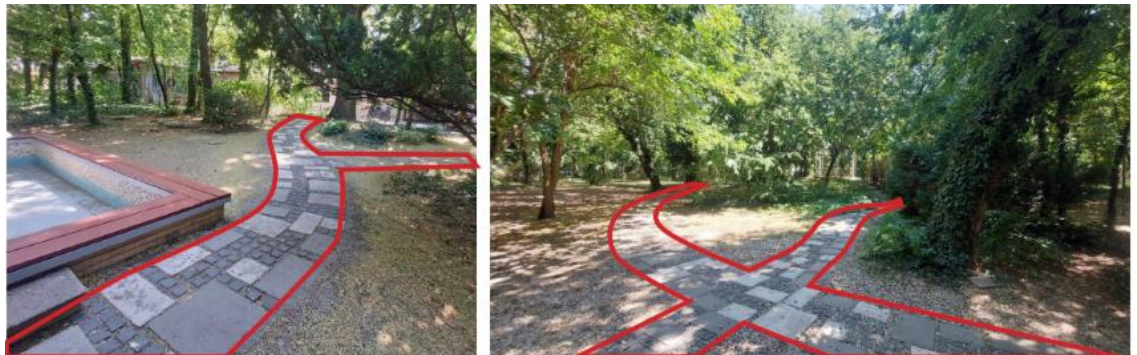
Collage of images capturing the garden's historic alleys, paved with stone slabs, concrete slabs and cubic stone, 2022. Source: Triboi, & co., 2022

24. It is recommended to remove the gravel layer and restore the historical alleys. It is recommended to re-evaluate the paving made of cubic stone, concrete slabs and stone slabs and identify the possibility of integrating it into the restoration proposal.

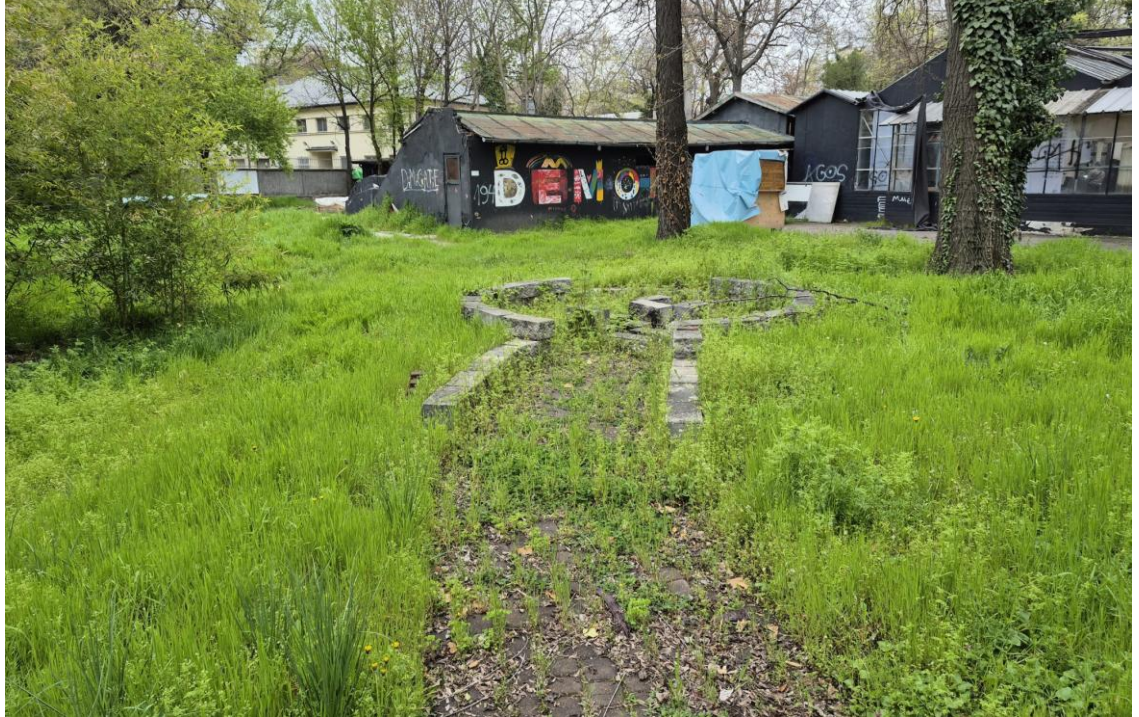
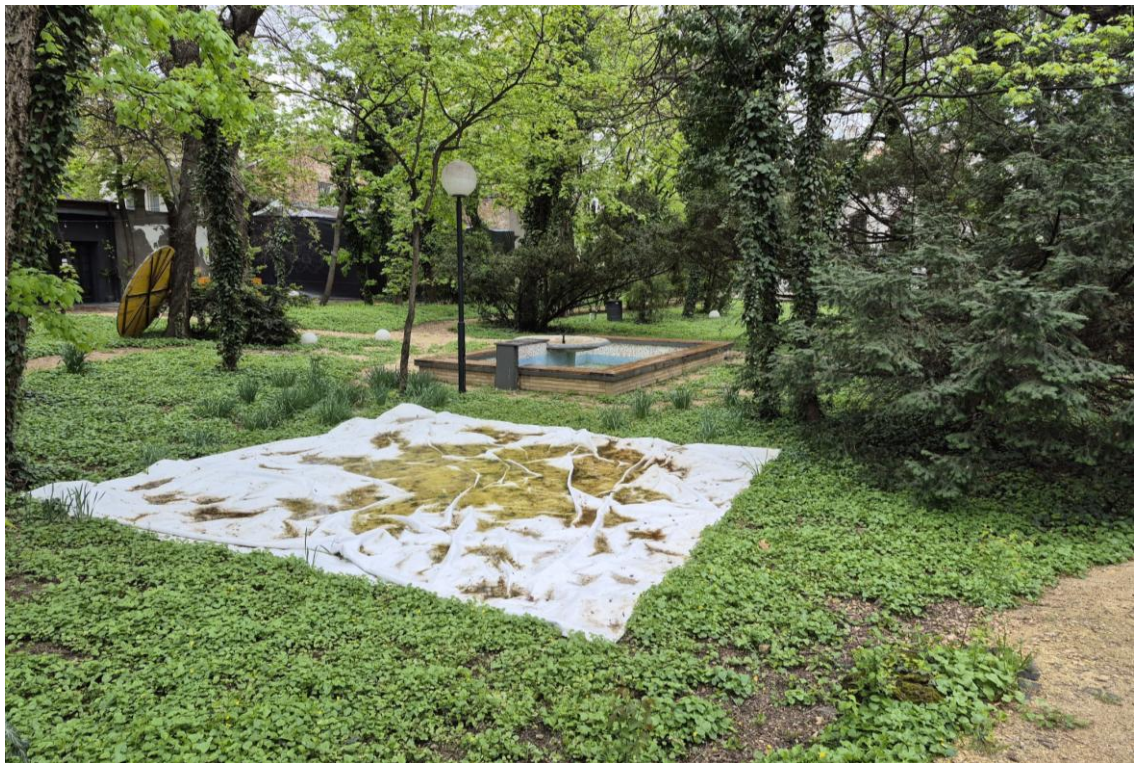
plant components. A differentiated level of maintenance is observed by area: the entrance area benefits from a relatively high degree of maintenance, indicating a higher frequency of maintenance work; the central area reflects a moderate to low level of care, with visibly degraded elements; and the eastern area presents a minimal level of maintenance.

Examples of areas lacking routine maintenance (top in the eastern half of the plot, bottom in the median area of the plot). Source: authors, 2025
