REPORT

Regarding the quality check of the Af requirement of the geotechnical study:

SERVICES FOR PREPARING A TECHNICAL EXPERTISE OF THE ANNEXES AND THE GREENHOUSE LOCATED IN THE COURTYARD OF THE LIBRECHT - FILIPESCU HOUSE, NOW UNIVERSITY HOUSE (HISTORICAL MONUMENT CODE LMI

Phase: **Geotechnical study**

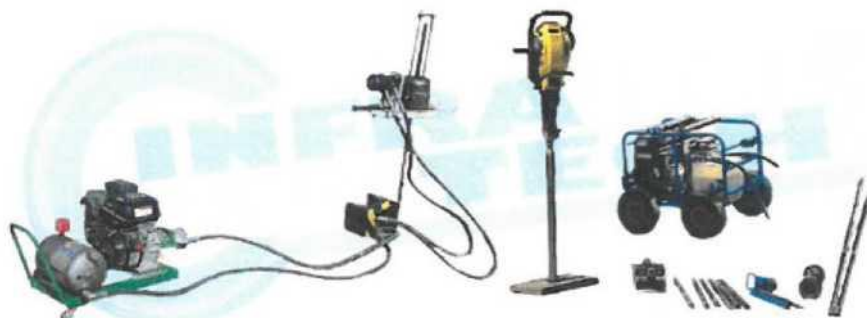
Geotechnical drilling was carried out with semi-mechanized drilling, with disturbed and undisturbed samples taken. The diameter of the drilling is = 100.0/mm. The geotechnical drilling was carried out in accordance with SR EN ISO 22475-1:2008.

Figure 17. Equipment used to carry out the geotechnical study

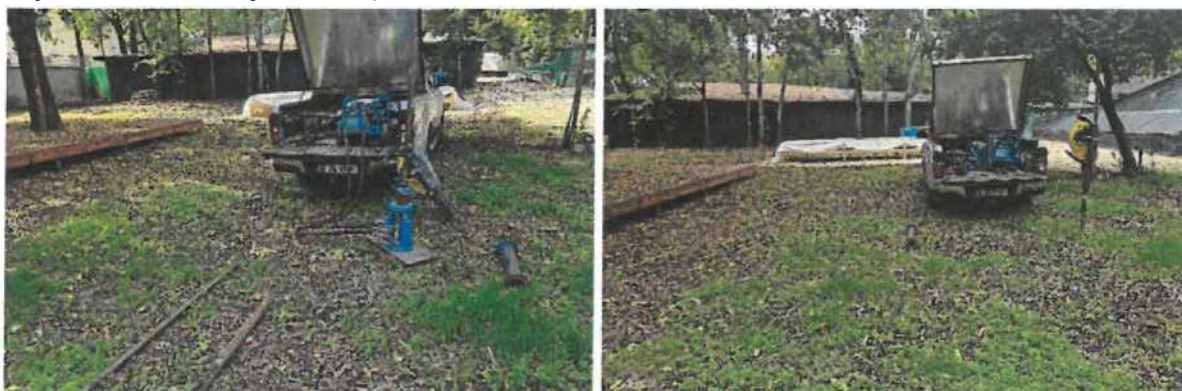
Figure 18. Geotechnical drilling

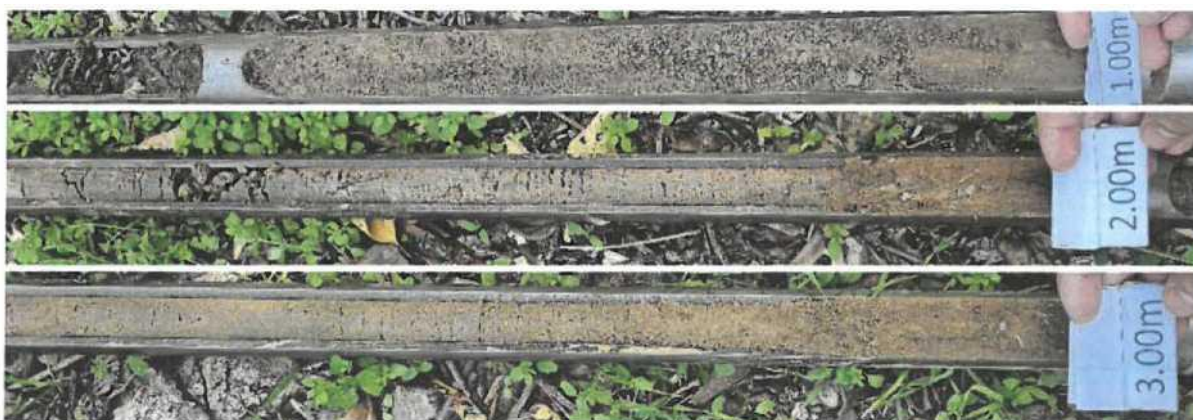
Figure 19. Sampling

The samples were stored in the laboratory in a desiccator to preserve the initial conditions at the site. The collection, transport and storage were carried out in accordance with SR EN 180 22475-1:2008.

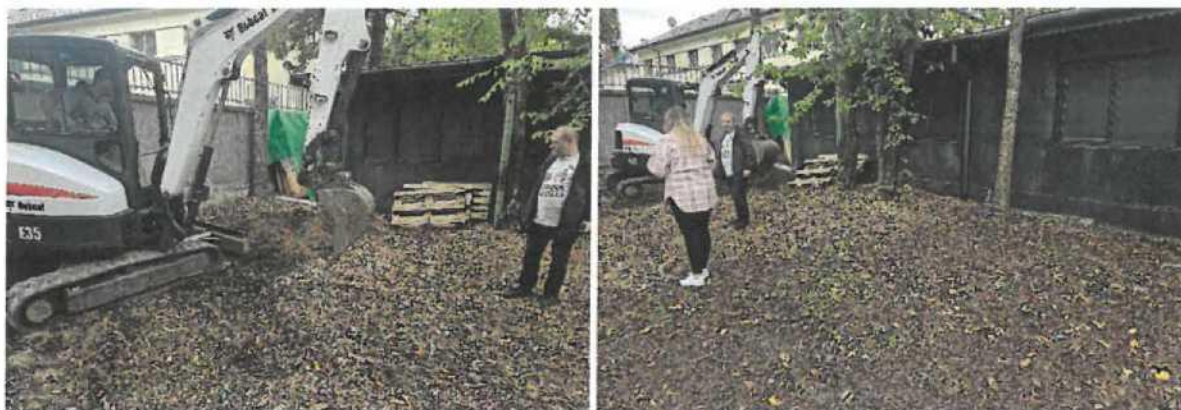
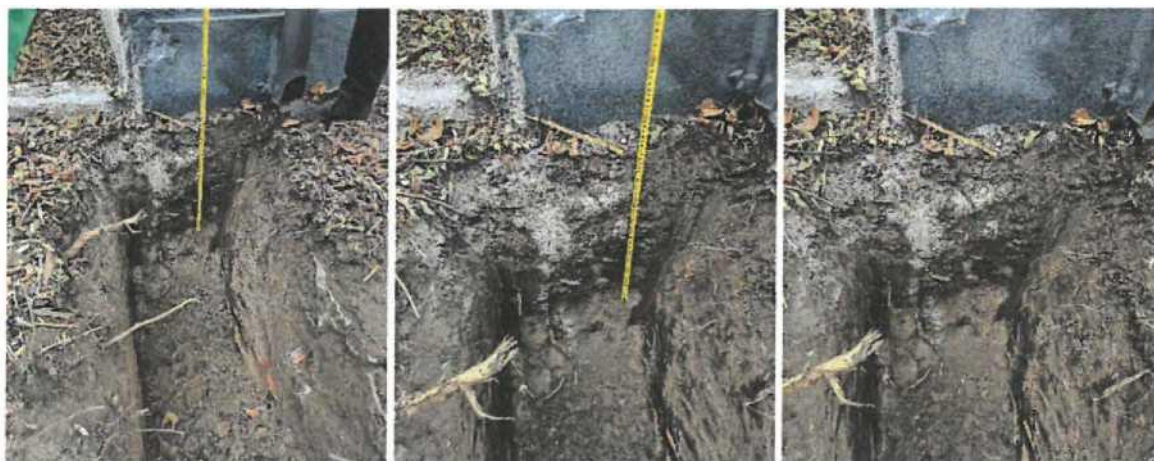
Figure 23 Carrying out geotechnical survey S01

Figure 24. Geotechnical survey S01

- The external foundations of the investigated construction are made of concrete and are arranged at a depth of 0.70m from the elevation of the developed land; **they do not exceed the frost depth** according to STAS 6054-77;
- The hydrostatic level was not intercepted;
- The type of existing foundation does not comply with the minimum requirements set out in the current SR EN 1997-1:2004 standards, therefore work is required to increase the foundation depth to a depth of 1.10m in the layer of brown sandy silty clay with medium plasticity, soft to hard plasticity, with medium compressibility.

When carrying out the consolidation of existing foundations, the following recommendations will be taken into account:

- The minimum foundation depth will be 1.10m from the level of the developed land;
- When carrying out foundation rehabilitation works, increased attention will be paid to supporting the earth banks according to NP 120-2014 Normative requirements for the design, execution and monitoring of deep excavations in urban areas.

- An increase in the foundation depth will be carried out by means of sub-constructions. The substructure will be carried out starting with the even-numbered sections, having a maximum length of 1.10m, followed by the odd-numbered sections. Due to the risk of water infiltration, all infrastructure works will be adequately waterproofed.

- Increasing the bearing capacity of the foundations by increasing their contact surface with the foundation ground, so that through the rehabilitation of the construction the bearing capacity of the ground beneath the existing foundations can be ensured;

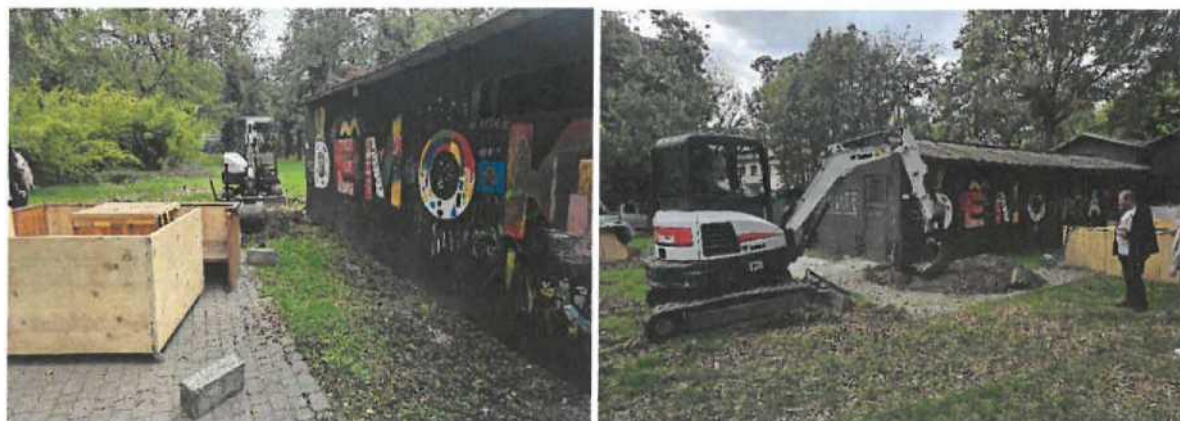
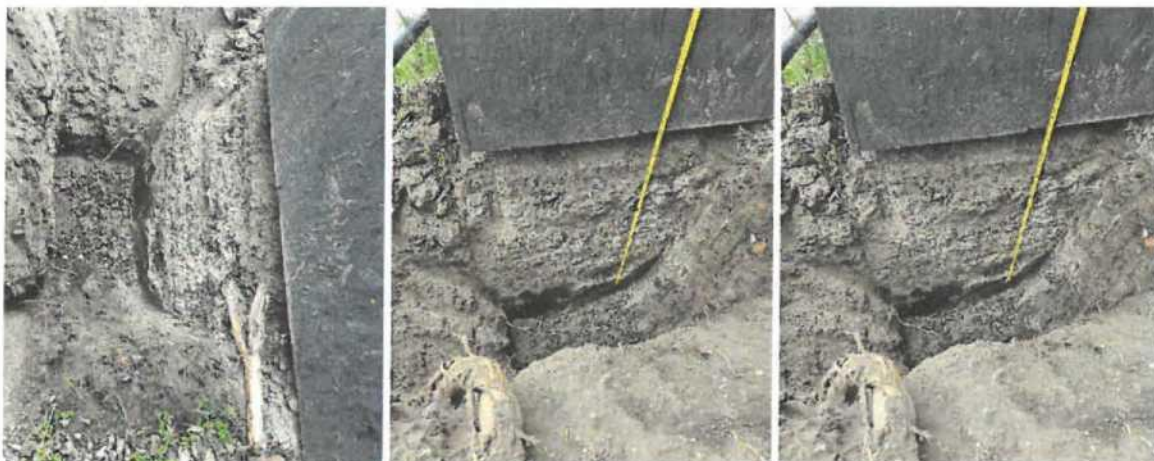
Figure 25 Carrying out geotechnical survey S02

Figure 26 Carrying out geotechnical survey S02

- The exterior foundations of the investigated construction are made of concrete and are arranged at a depth of 1.20m from the elevation of the developed land; they thus exceed the frost depth according to STAS 6054-77;
- The hydrostatic level was not intercepted;
- The building's foundation does not have a waterproofing system;
- The type of existing foundation **complies with the minimum requirements** set out in the current SR EN 1997-1:2004 standards, therefore no work is required to increase the foundation depth.

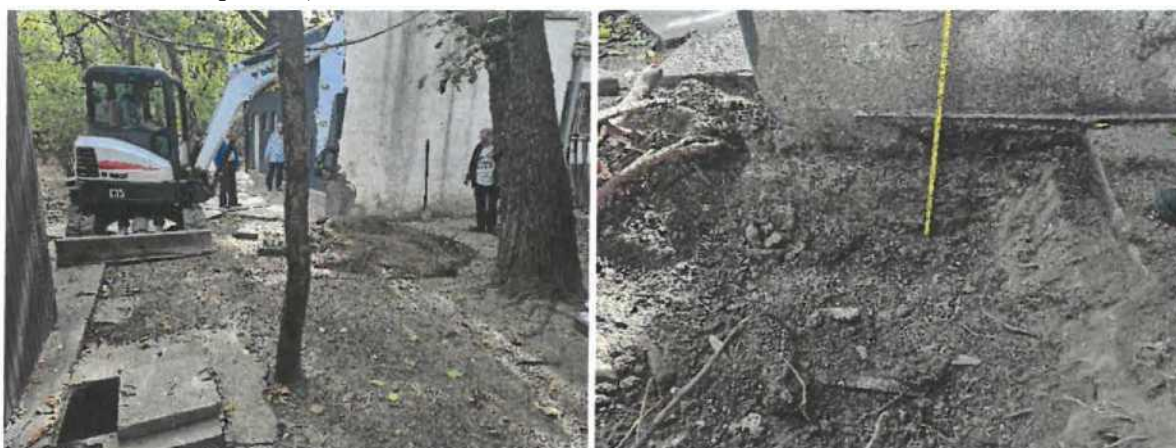
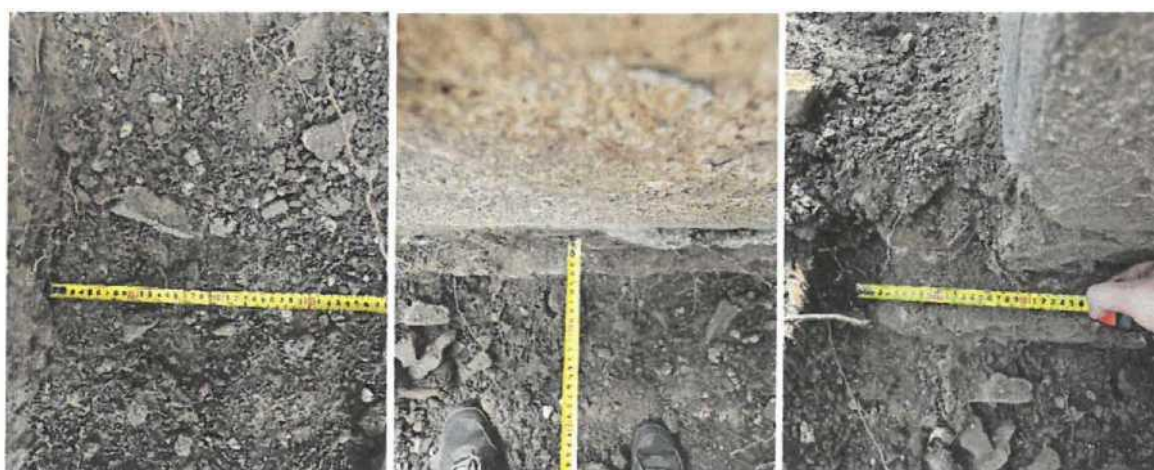
Figure 27. Geotechnical survey S03

Figure 28. Geotechnical survey S03

- The exterior foundations of the investigated construction are made of concrete and are arranged at a depth of **1.10 m** from the elevation of the developed land; they thus exceed the frost depth according to STAS 6054-77;
- The hydrostatic level was not intercepted;
- The building's foundation does not have a waterproofing system;
- The type of existing foundation **complies with the minimum requirements** set out in the current SR EN 1997-1:2004 standards, therefore no work is required to increase the foundation depth.
