Technical expertise

on greenhouses and annex buildings located in the courtyard of the Libreht House

"Services for preparing a technical expertise of the annexes and the greenhouse located in the courtyard of the Libreht - Filipescu House, now University House – (historical monument, LMI B-II-M-A-19107 code)"

Objective:	Building C7, C8, C10-C11, C12, C13, C15, C16, C17, C18, C20, C22, C24, C25, C26, C27, C28-C29 (according to the topographic plan)
Study beneficiary:	Bucharest University
Real estate location:	Bucharest Municipality, Dionisie Lupu Street, no. 46
Internal project number:	363/2024
Phase:	technical expertise
Date:	December 2024
Revision:	00

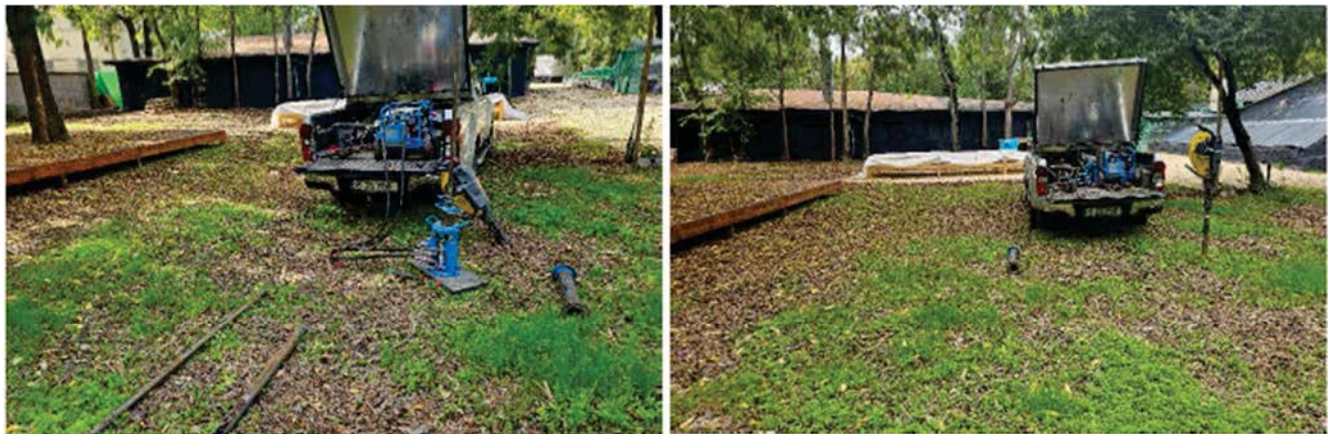
Figura 18. Realizare foraje geotehnice

Disturbed and undisturbed samples were taken from the geotechnical drillings, which were analyzed in the laboratory, highlighting the following stratification:

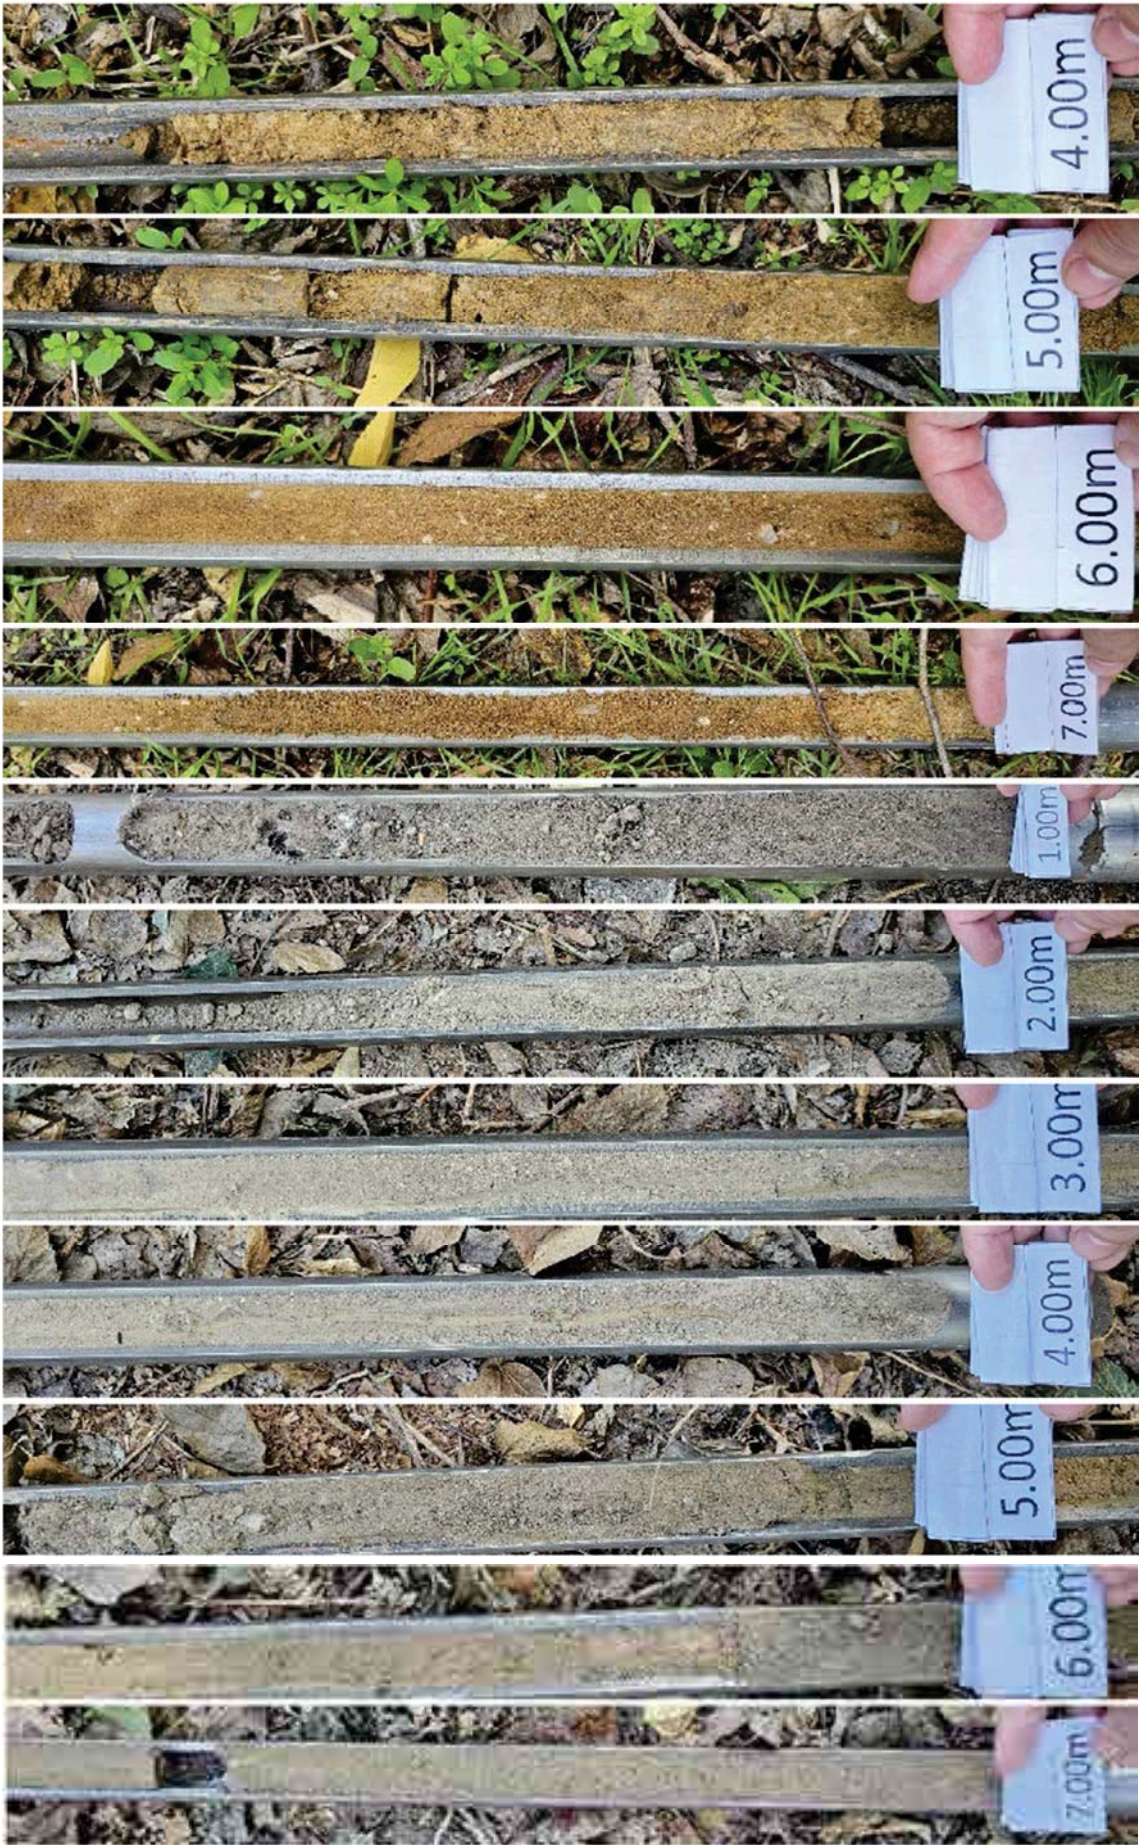
SURVEY S01 (The reference level of the elevations and the depth of the survey were reported to the C.T.A. - considered to be depth 0.00)

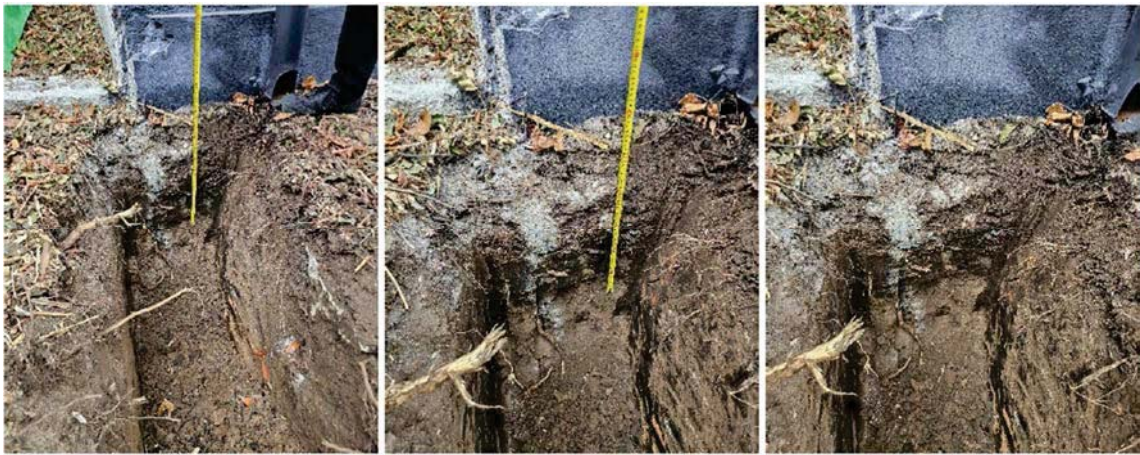
SURVEY S02 (The reference level of the elevations and the depth of the survey were reported to the C.T.A. - considered to be depth 0.00)

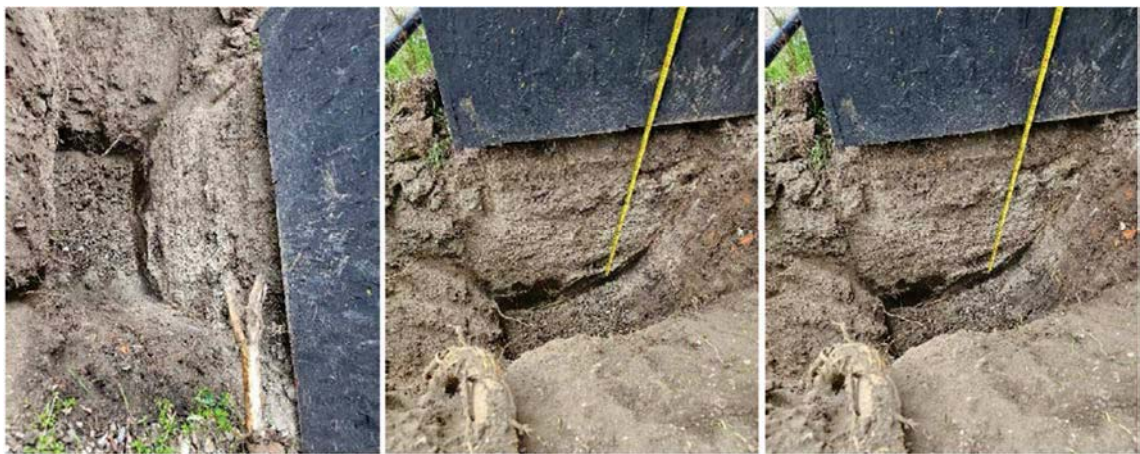
SURVEY S03 (The reference level of the elevations and the depth of the survey were reported to the C.T.A. - considered to be depth 0.00)

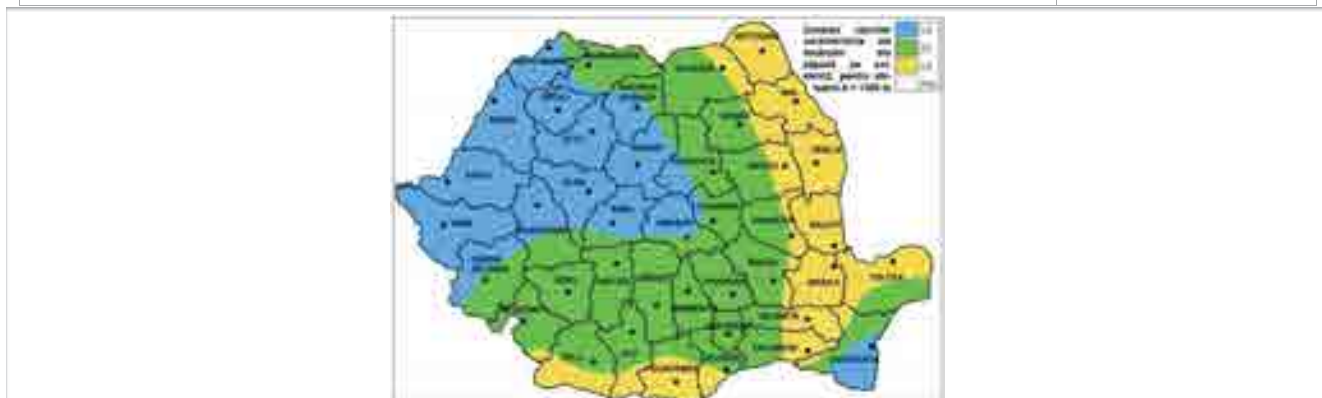
Figure no. 4 - Zoning map of the characteristic value of the given snow load (IMR = 50 years)

Loading from packed and unpacked snow - $S_k = \mu_i \cdot C_e \cdot C_t \cdot S_{0k}$	
γ – importance-exposure factor for snow action acc.to. CR1-1-3/2012	1.00
μ_i – the shape coefficient of the given snow load acc.to. CR1-1-3/2012	0.8
C_e – exposure coefficient acc.to. CR1-1-3/2012	1
C_t – thermal coefficient acc.to. CR1-1-3/2012	1
s_k – the characteristic value of the load given by the snow on the ground acc.to. CR1-1-3/2012	2.00 kN/m ²
Total loads	$S_k = 1.60 \text{ kN/m}^2$

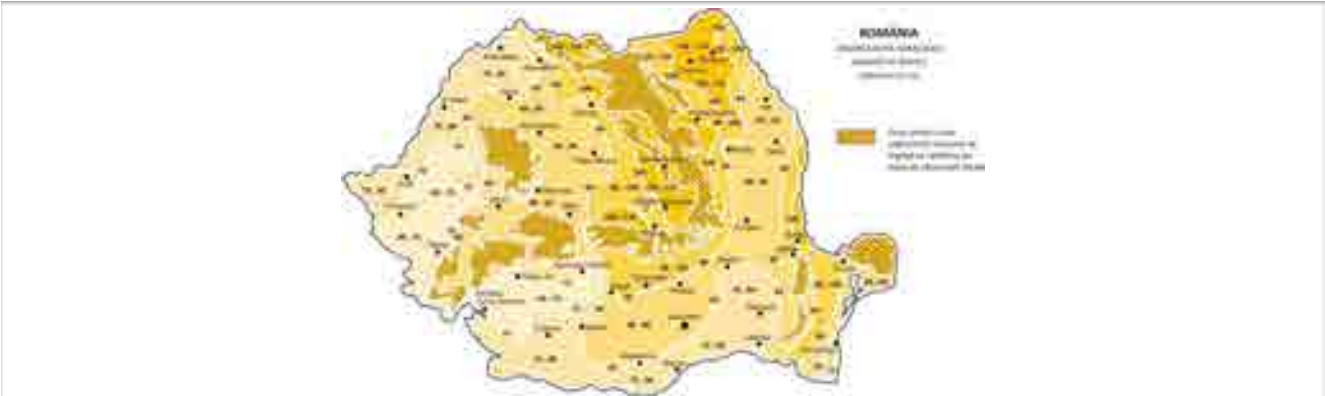
Figure no. 5 - Zoning map of maximum freezing depth

The maximum freezing depth in the site area is 80-90 cm from the ground surface, according to STAS 6054-77.

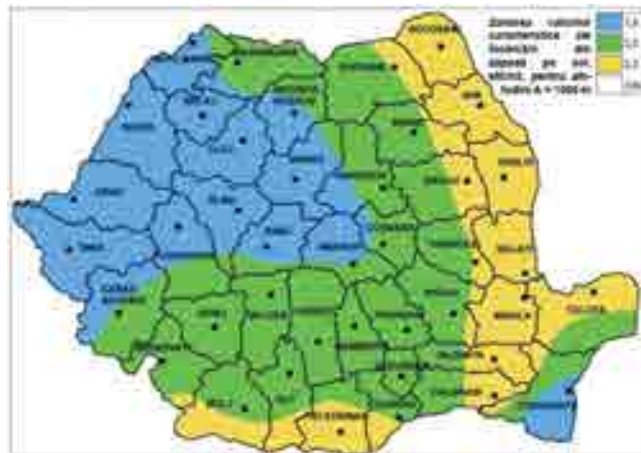
Figure no. 1 - Zoning map of the characteristic value of the given snow load
(IMR = 50 years)

Loading from packed and unpacked snow – $S_k = \mu_i \cdot C_e \cdot C_t \cdot S_k$	
γ – importance-exposure factor for snow action acc.to CR1-1-3/2012	1.00
μ_i – the shape coefficient of the given snow load acc.to CR1-1-3/2012	0.8
C_e – exposure coefficient acc.to CR1-1-3/2012	1.0
C_t – thermal coefficient acc.to CR1-1-3/2012	1.0
s_k –the characteristic value of the load given by the snow on the ground acc.to CR1-1-3/2012	2.00 kN/m ²
Total loads	p_{1,k} = 1.60 kN/m²

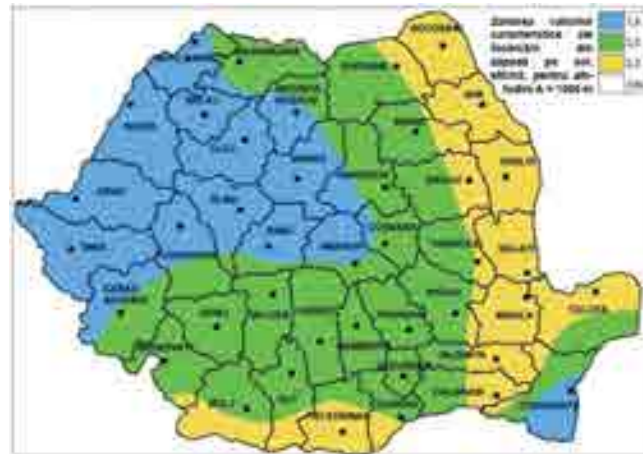
Figure no. 5 - Zoning map of the characteristic value of the given snow load (IMR = 50 years)

Loading from packed and unpacked snow – $S_k = \mu_i \cdot C_e \cdot C_t \cdot S_{k0}$	
γ – importance-exposure factor for snow action acc.to CR1-1-3/2012	1.00
μ_i – the shape coefficient of the given snow load acc.to CR1-1-3/2012	0.8
C_e – exposure coefficient acc.to CR1-1-3/2012	1.0

C _t – thermal coefficient acc.to CR1-1-3/2012	1.0
s _k –the characteristic value of the load given by the snow on the ground acc.to CR1-1-3/2012	2.00 kN/m ²
Total loads	p_{1,k} = 1.60 kN/m²

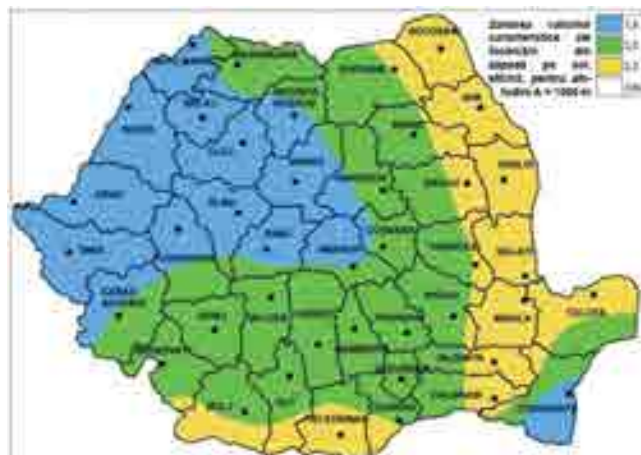
Figure no. 2 - Zoning map of the characteristic value of the given snow load (IMR = 50 years)

Loading from packed and unpacked snow – $S_k = \mu_i \cdot C_e \cdot C_t \cdot s_k$	
γ – importance-exposure factor for snow action acc.to CR1-1-3/2012	1.00
μ_i – the shape coefficient of the given snow load acc.to CR1-1-3/2012	0.8
C_e – exposure coefficient acc.to CR1-1-3/2012	1
C_t – thermal coefficient acc.to CR1-1-3/2012	1
s_k – the characteristic value of the load given by the snow on the ground acc.to CR1-1-3/2012	2.00 kN/m ²
Total loads	$p_{1,k} = 1.60$ kN/m²

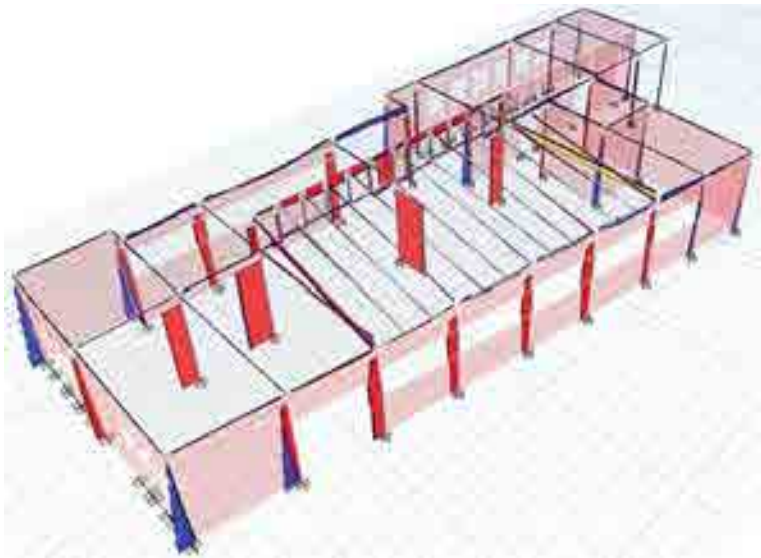
Axial stress diagram in columns

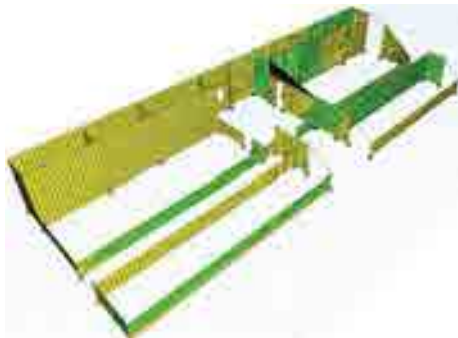
Vibration mode 1 (3D view)

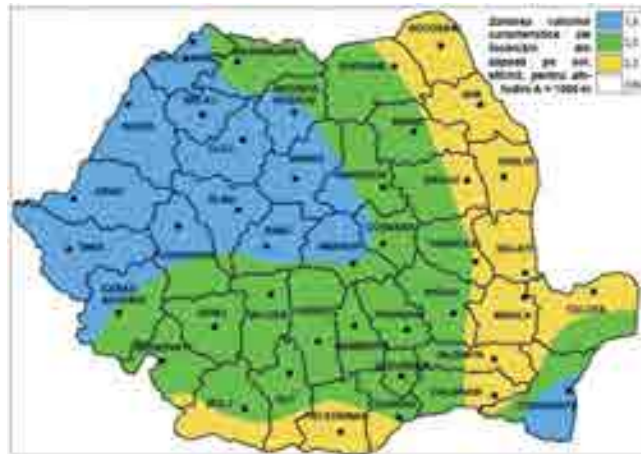
Figure no. 6 - Zoning map of the characteristic value of the given snow load (IMR = 50 years)

C _t – thermal coefficient acc.to CR1-1-3/2012	1.0
s _k – the characteristic value of the load given by the snow on the ground acc.to CR1-1-3/2012	2.00 kN/m ²
Total loads	p_{1,k} = 1.60 kN/m²
